The customer needed an inexpensive method to leak test automotive radiators. The existing process utilized helium mass spectrometry, and previous attempts to utilize pressure decay or mass flow resulted in long cycle times and poor Gage R&R (reliability and repeatability) in their production environment. The customer produces multiple designs of radiators and requires interchangeable tooling that is quick and easy to change.

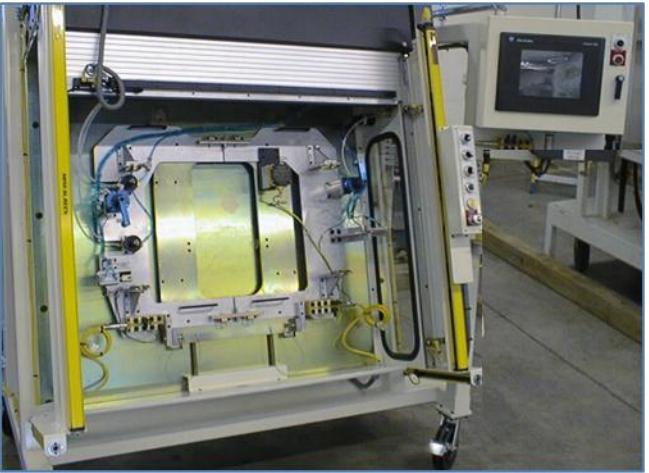
CTS engineers reviewed previous radiator test stands and incorporated the customers' requirements in a new design. The stands were constructed around an angled tool plate with hydraulic height adjustment on the part holder mounting position. Quick detach electrical and pneumatic manifolds were incorporated. The part holder inserts were designed using aircraft aluminum split vertically to meet a weight requirement. The test area was enclosed with an automatic roll up door to minimize the environmental effects on the part during the test cycle. A short vacuum pull down test was followed by a pressure decay leak test. Both tests were controlled by our standard Sentinel leak test instrumentation. The customer was able to save considerable cost utilizing pressure decay test stands to meet their required Gage R&R in their test cycle time. The versatility of the tooling design allowed the customer to change out their assembly line with little down time. The test stands have functioned for millions of cycles without significant maintenance. The customer has purchased multiple stands to maintain their demanding production schedule.
